Place Eighteen Condominium

Address: **1811 Eagle Harbor Dr., Bainbridge Island**

Project Type: **Toe protection,
Beach Nourishment**

Date Completed: **August 1997**

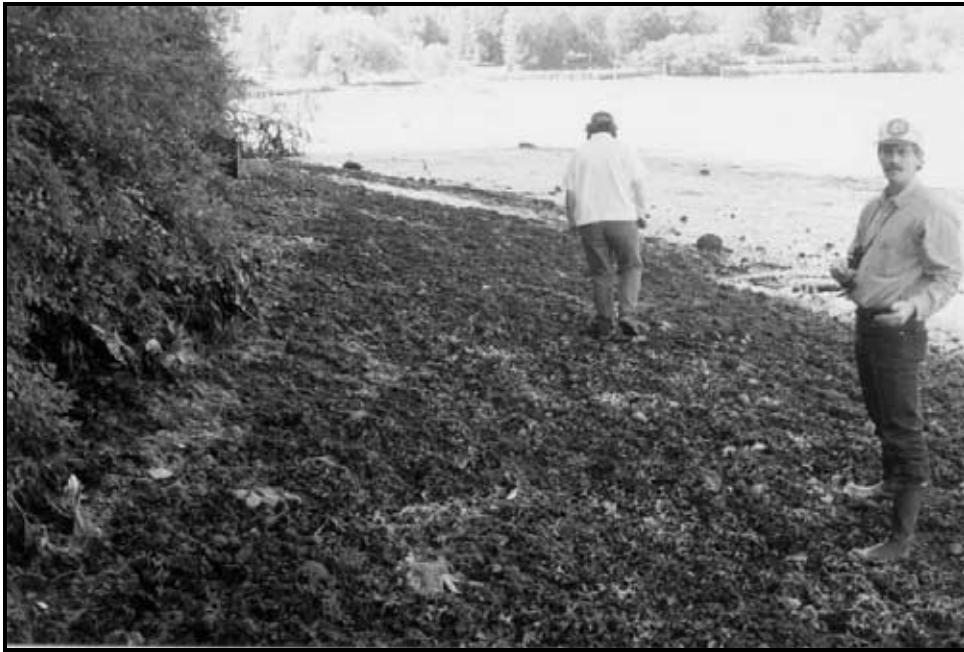
Figure 1. Gravel beach and vegetated bank. Quarry spall was placed at the toe of the slope and is largely covered with gravel. Aquatic vegetation is colonizing the coarse gravel, which is relatively stable in this low energy environment.

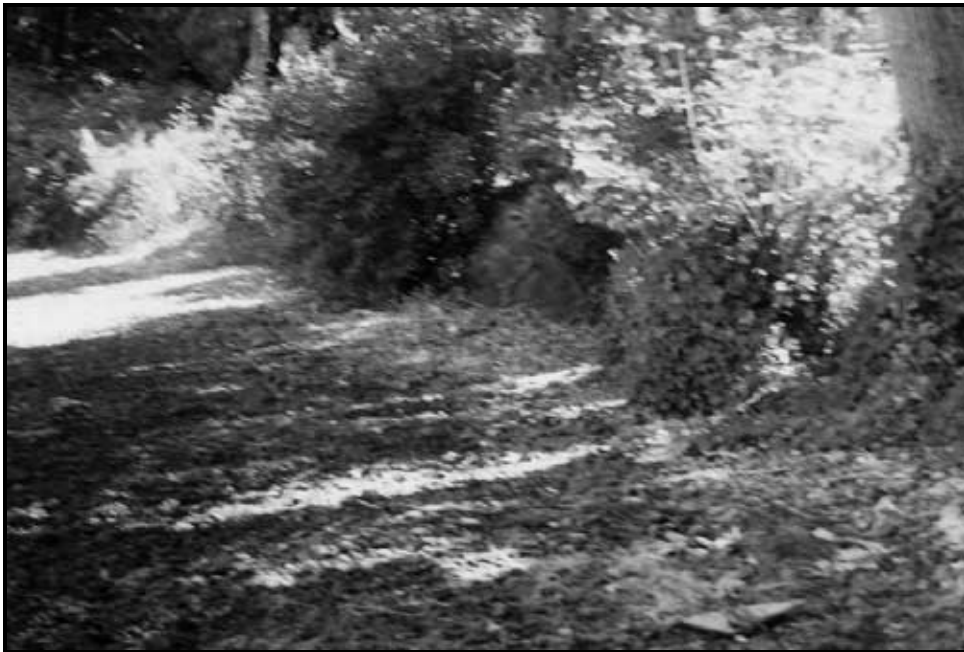
Figure 2. View of central portion of site, looking east. Note recent high tide line and wrack on gravel. By raising beach elevation, opportunities for waves to erode the toe of the bank are greatly reduced.

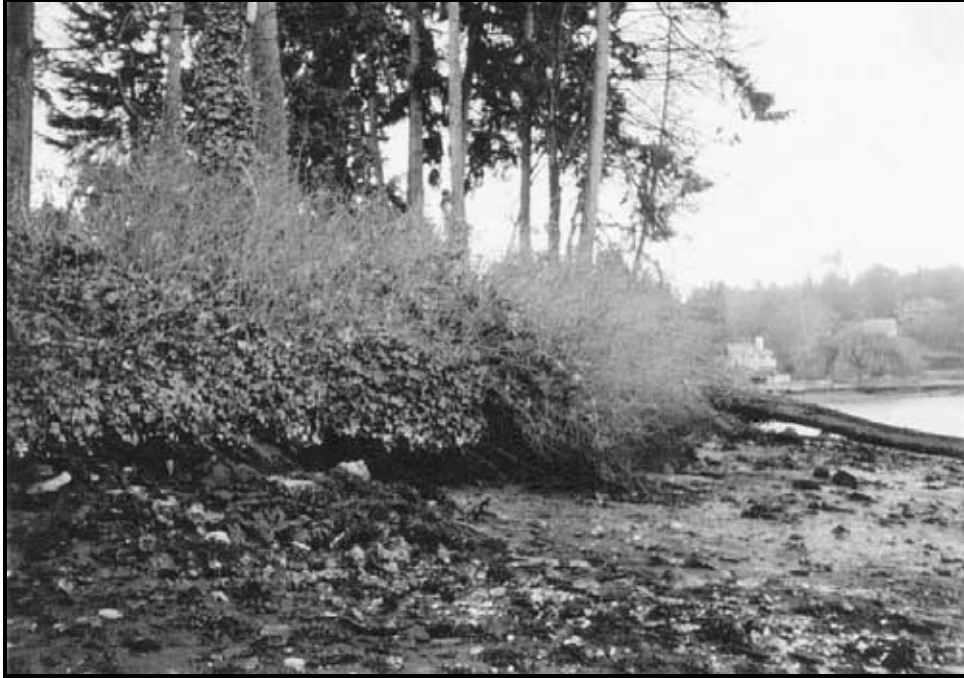
Figure 3. Beach and bank, looking west.

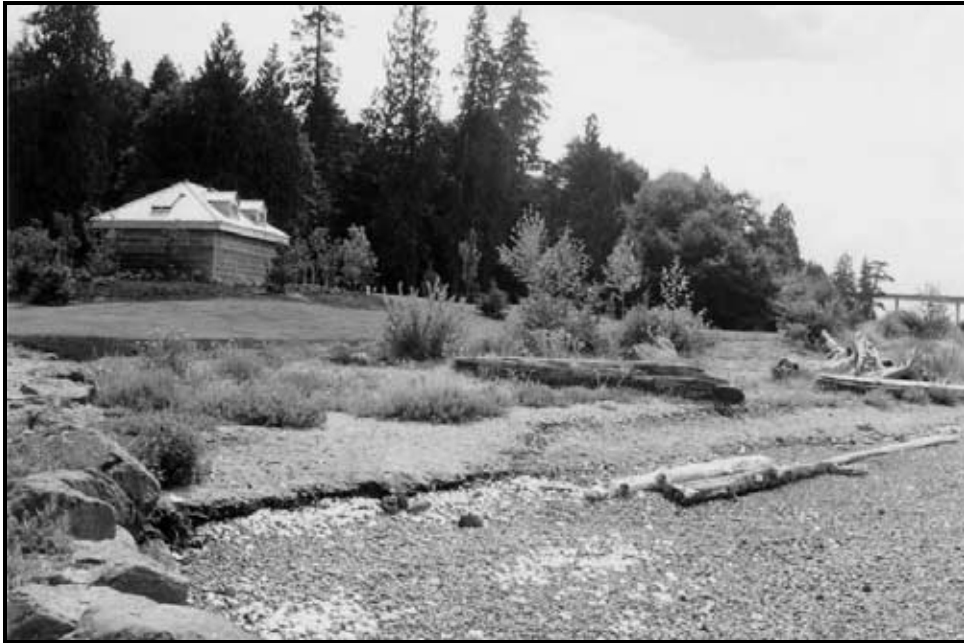
Figure 1. View west showing gravel beach and backshore. Large logs in the backshore were placed at construction, whereas most vegetation has reestablished naturally (1999).

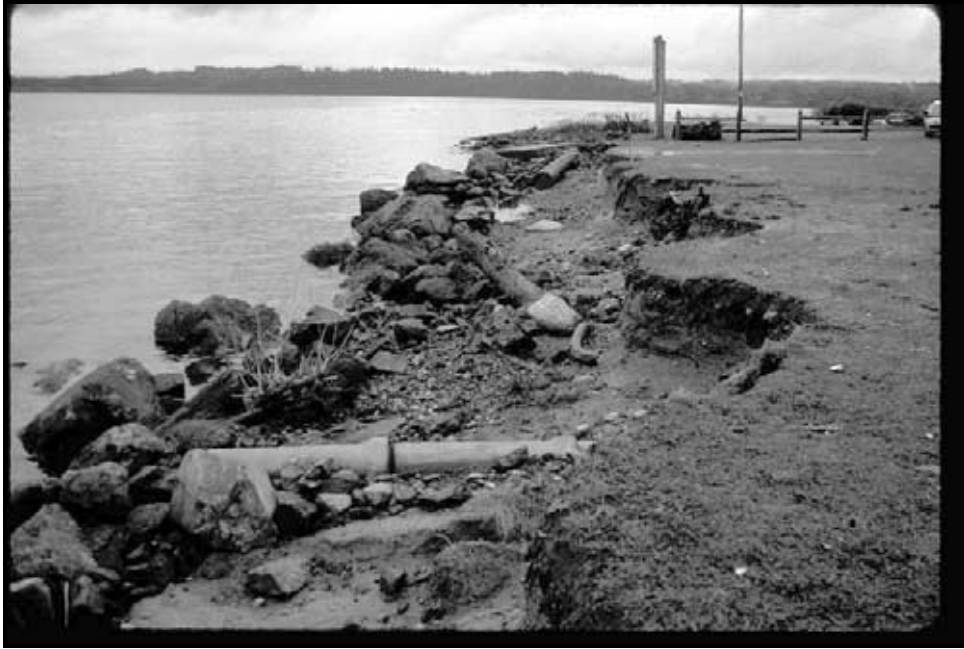
Figure 3. View east of project area prior to nourishment. Note scarp in eroding artificial fill and rocks placed in effort to reduce erosion (1995).

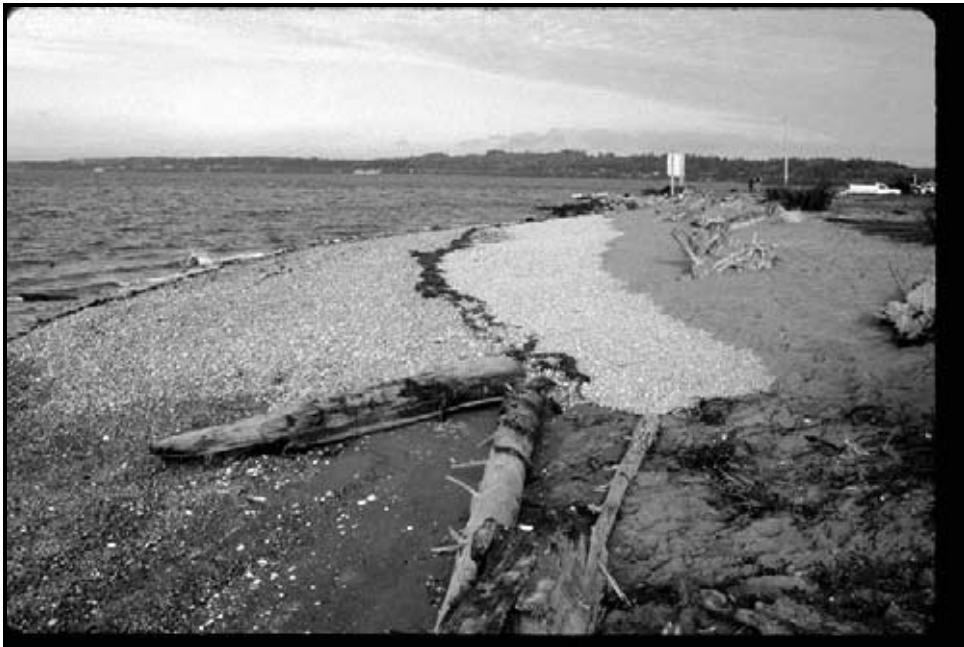
Figure 4. View to the east immediately following construction (Fall, 1995), showing gravel beach and recent high tide line. Note sand placed on landward portion of the berm.

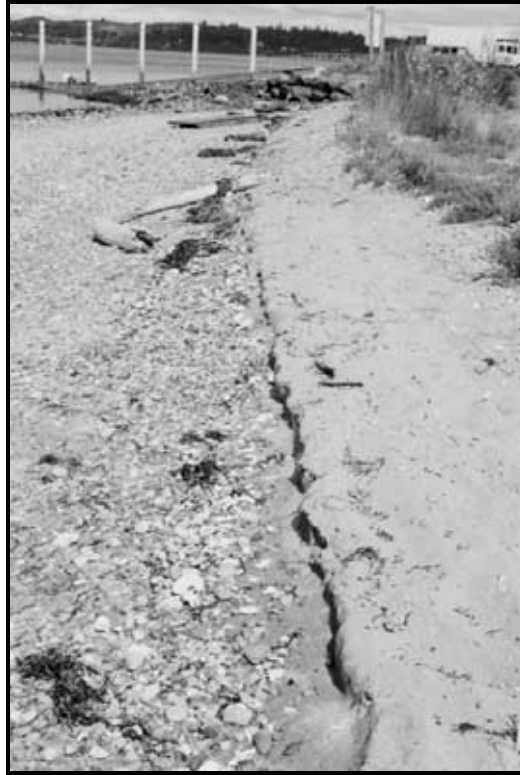
Figure 5. 1999 photo shows an erosional scarp in sandy berm. This sand was deposited during the winter of 1998-1999 by movement of drift from the south and was gradually eroded by summer wave action from the north. This illustrates natural variability common to both natural and nourished beaches.

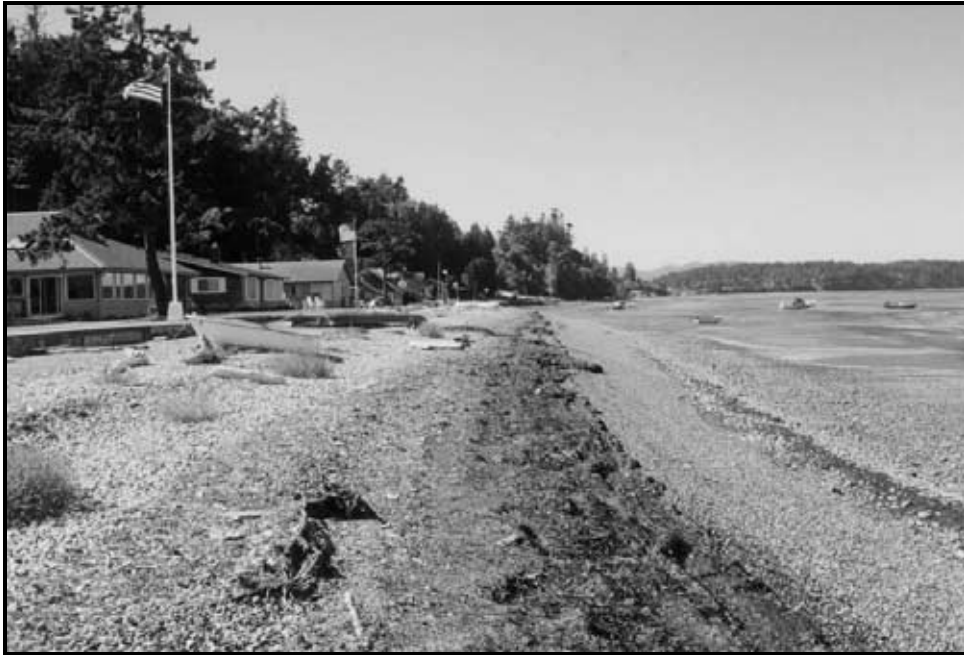
Figure 1. View west from the east end of the project. Note broad gravel berm and recent accumulation of beach wrack. Prior to nourishment, the bulkheads at the left were in danger of undermining.

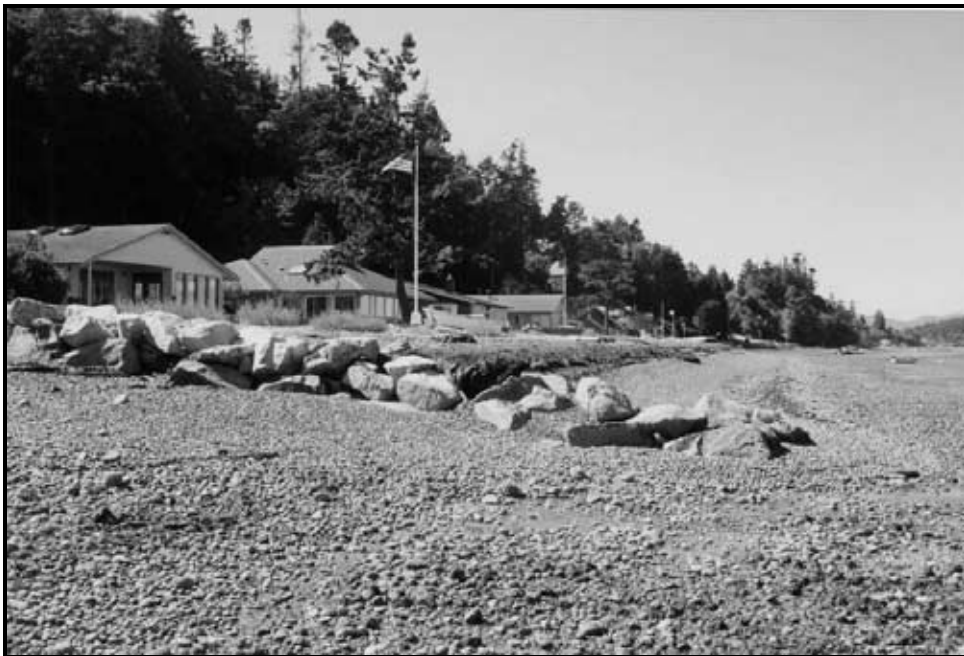
Figure 2. Looking west at project, including drift sill (groin) that forms eastern end of nourishment. Note that beach is considerably lower on east (left) side of structure. It is important that gravel be able to continue to bypass the structure in order to feed downdrift beaches.

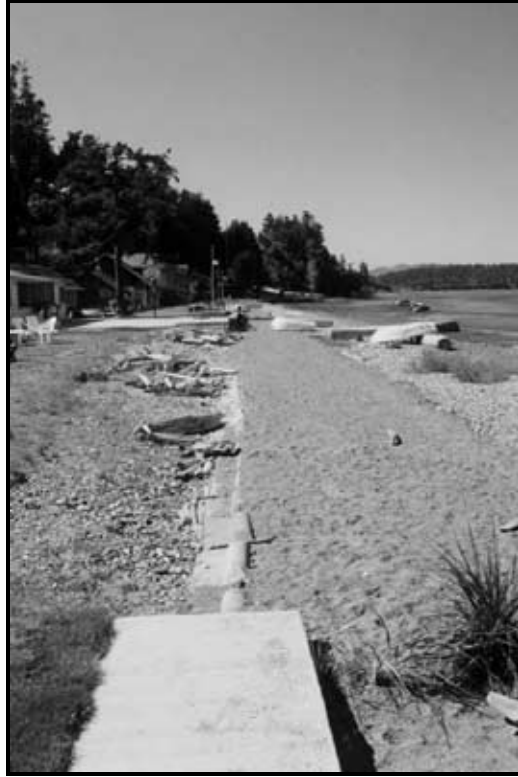
Figure 3. View west along bulkhead line in central portion of project. The bulkhead in the foreground failed in the winter of 1996-1997 (see Figure 6). Note elevation of backshore and placement of sand to facilitate revegetation.

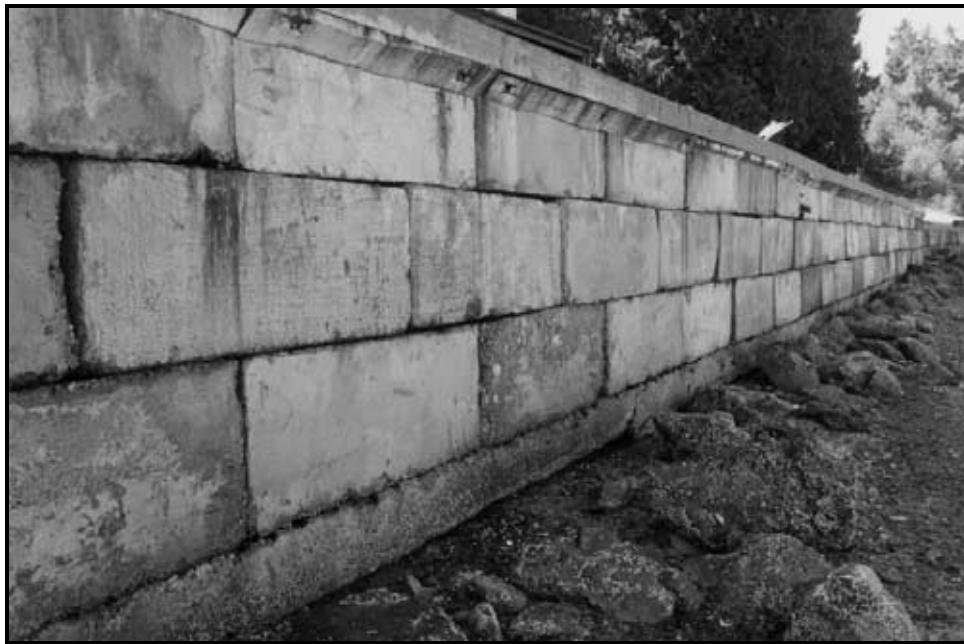
Figure 4. Ecology-block bulkhead located immediately west of project area.. Riprap has been added to protect base from scour.

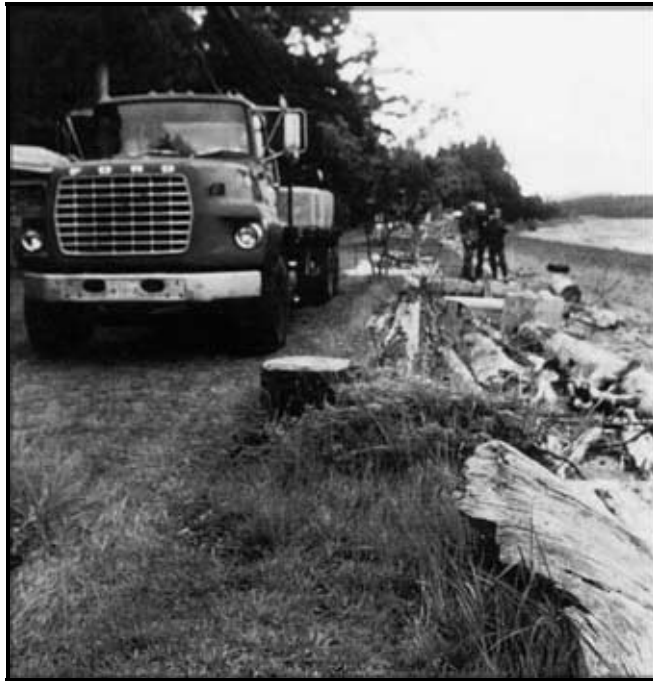
Figure 5. Photo taken immediately prior to bulkhead construction in 1982 along east-central portion of project site. Note line of drift logs and narrow berm
(Photo: courtesy of Marge Dunnington)

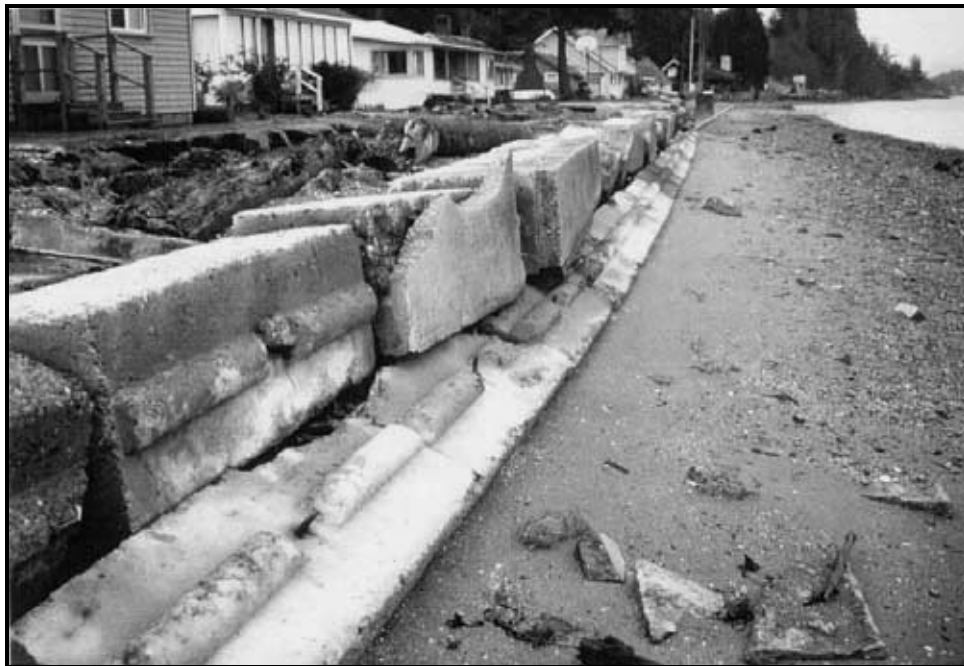
Figure 6. Ecology-block wall prior to nourishment. Failure occurred in the winter of 1996-1997 by undermining and excess hydrostatic pressure - upper tier has been restacked in this photo. Note erosion of upland area behind wall.
